GREENSTONE LAND DEVELOPMENTS LIMITED

STAGE 12, LYNDHURST SUBDIVISION,
HASTINGS

GEOTECHNICAL COMPLETION REPORT

INITIA REF P-000828 REV A

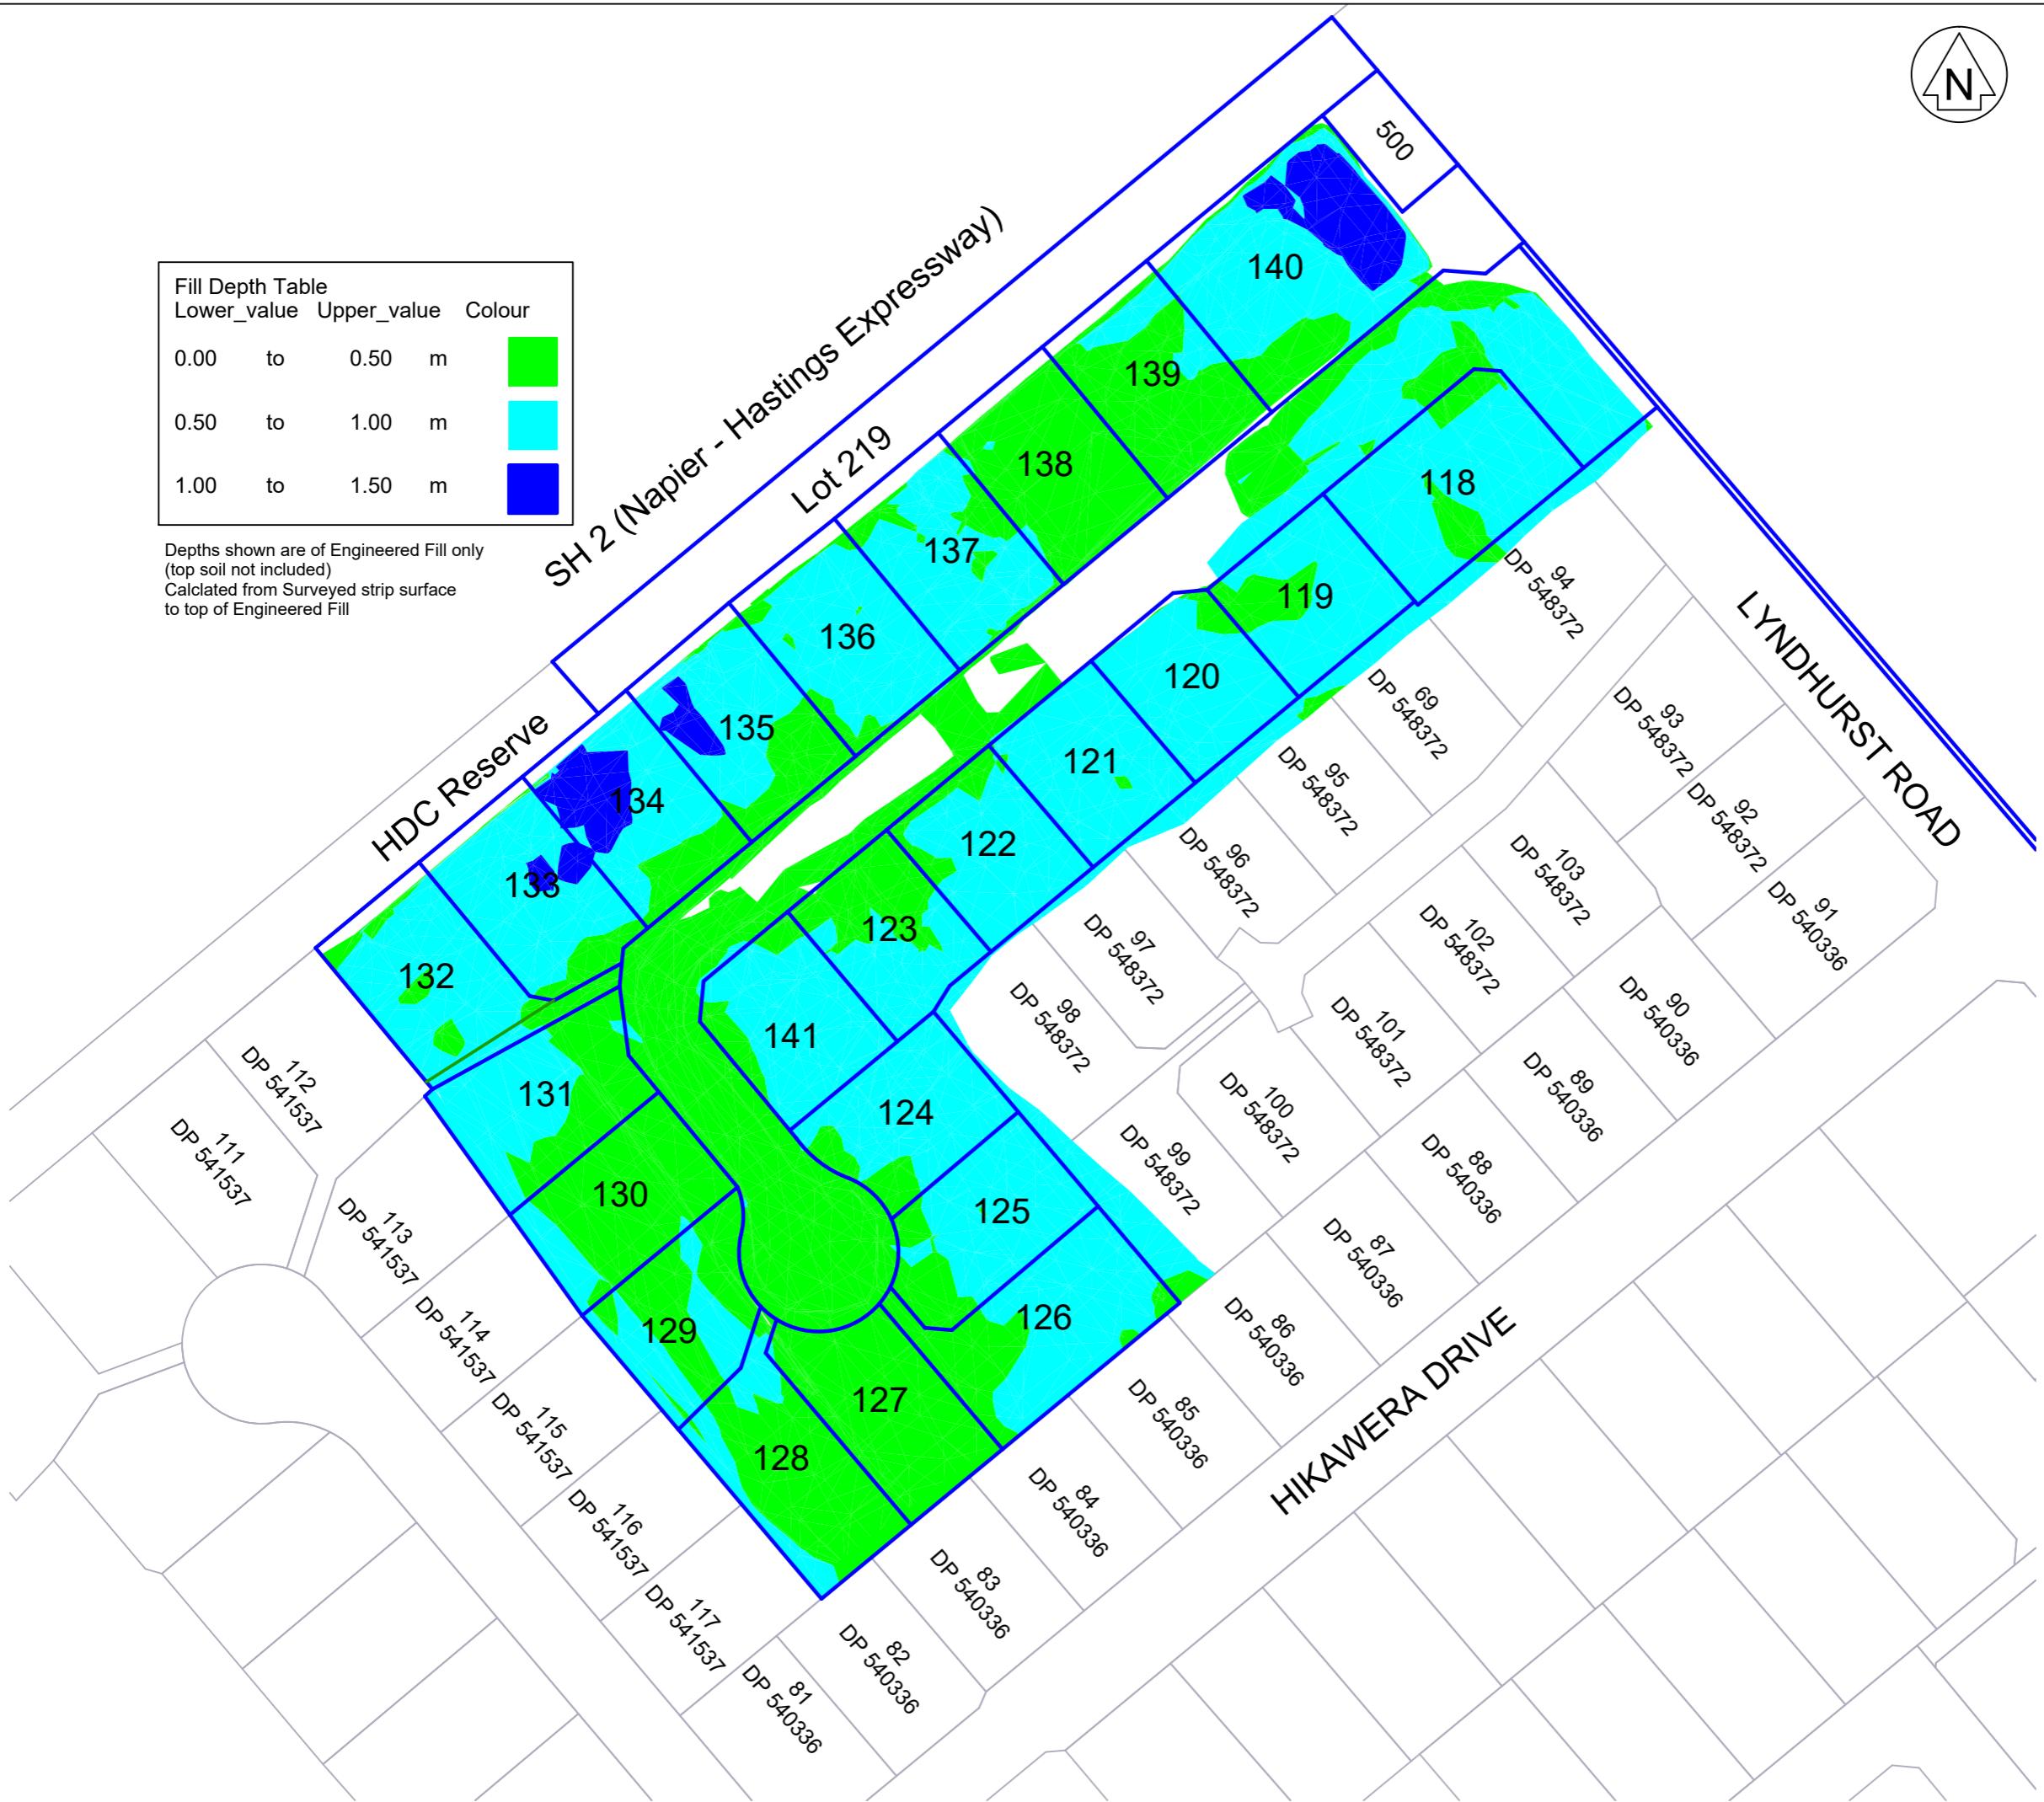
SANTO CONSTRUCTION
C/O GLDL
ENGINEERED FILL
SURVEYED DEPTHS

As shown on the Zorn Surveying fill depth plan² attached in Appendix A, earthworks including the placement of engineered fill up to 1.5 m depth has been completed for most of the site. Initia has recently carried out a geotechnical site investigation for the Stage 12 area (refer the investigation plan attached in Appendix B).

DATE : Varies over 2020
SCALE : 1:1000 @ A3
DRAWN BY : R.Mac
JOB NO. : J001255
PLAN NO. : EFDS12

- The earth fill shown on the attached Zorn Surveying Plan (Ref J001255-EFDS12) have been generally placed in compliance with the project specifications.
- The completed earthworks give due regard to land slope stability and foundation consideration providing the recommendations outlined in this Geotechnical Completion Report are followed.

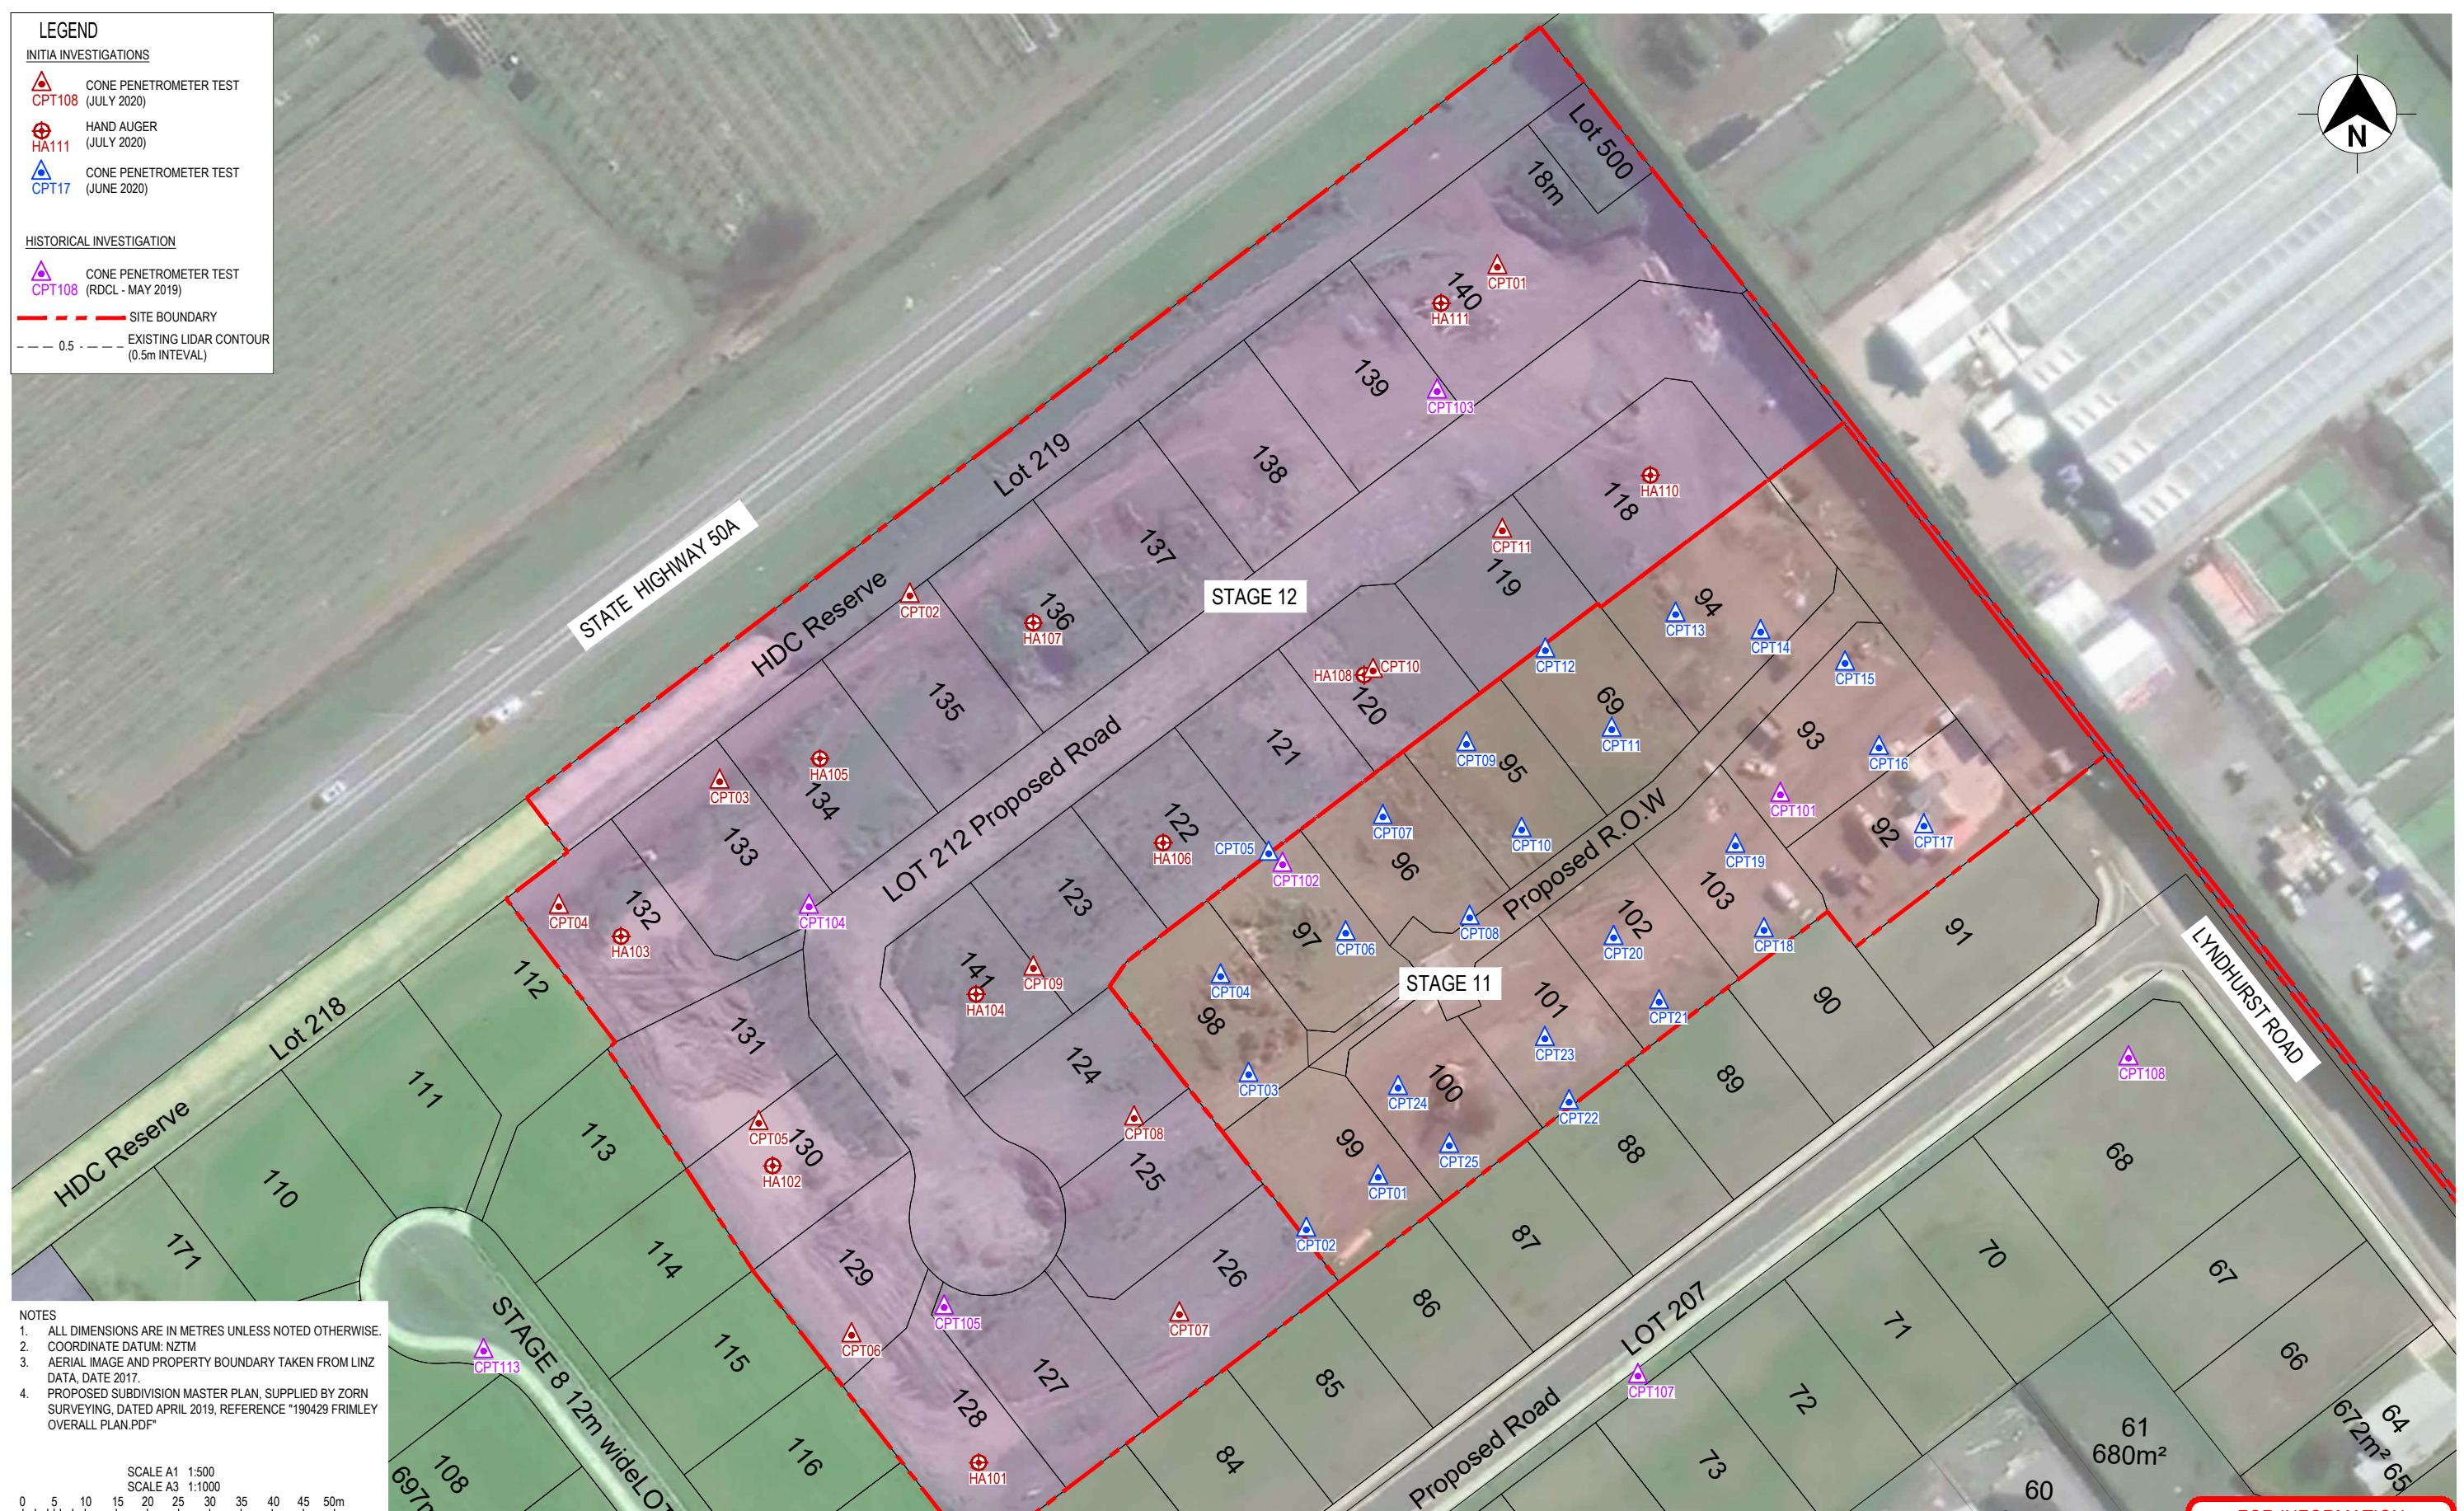
Appendix B: Geotechnical Investigation Plan

On 30 and 31 July 2020, Initia carried out 11 No. CPTs and 10 No. hand auger boreholes (shown in red colour on the investigation plan attached in Appendix B) within the Stage 12 area to provide Greenstone with a geotechnical completion report for subdivision. This document will provide potential purchasers of each lot with the required geotechnical information to enable a Building Consent Application to be submitted to Hastings District Council.

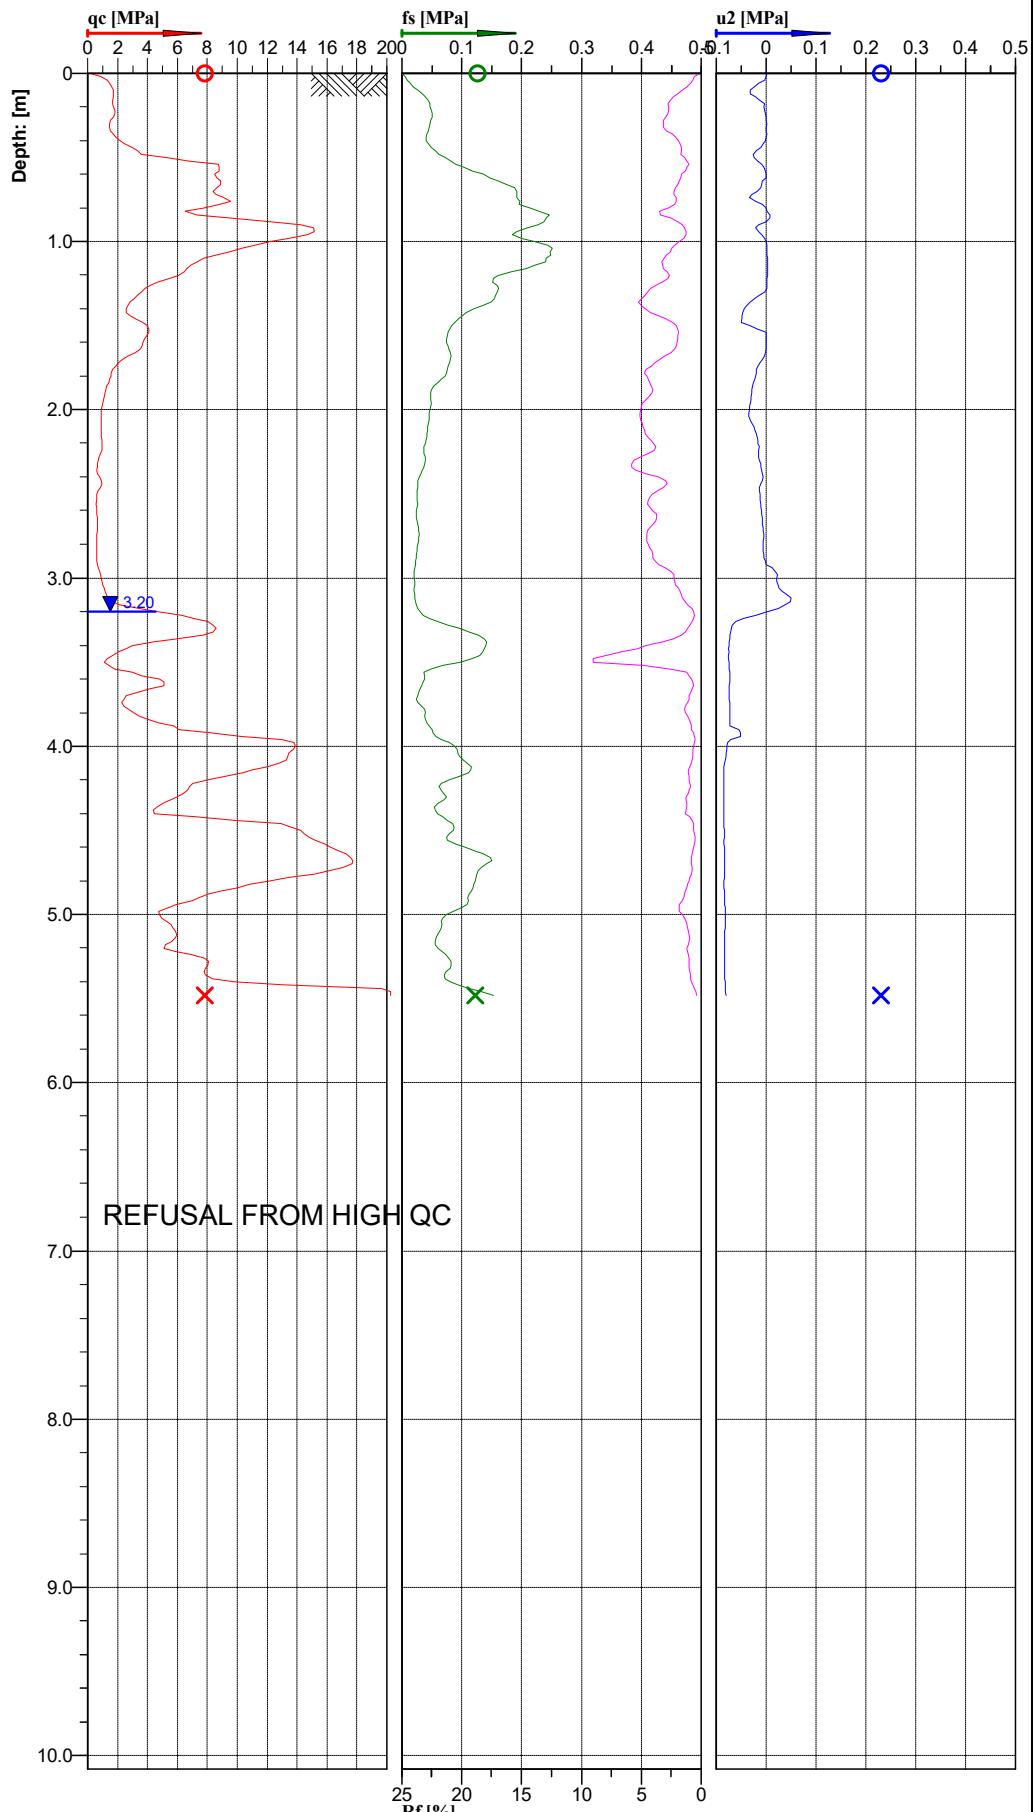
Location:	HASTINGS	Position:	X: 0.00 m, Y: 0.00 m	Ground level:	0.00	Test No.:	CPT01
Project ID:	P000828	Client:	INITIA	Date:	30/07/2020	Scale:	1 : 45
Project:	LYNDHURST ROAD						Page: 1/1 Fig.:
	S 39.61432, E 176.82654						File: CPT01.cpt

5 No. of the Initia CPTs were pushed down to the target depth of 15 m below ground level and the other 6 No. CPTs reached refusal due to high cone resistance q_c (greater than 20 MPa) at variable depths of 5.4 to 14.4 m below ground level.

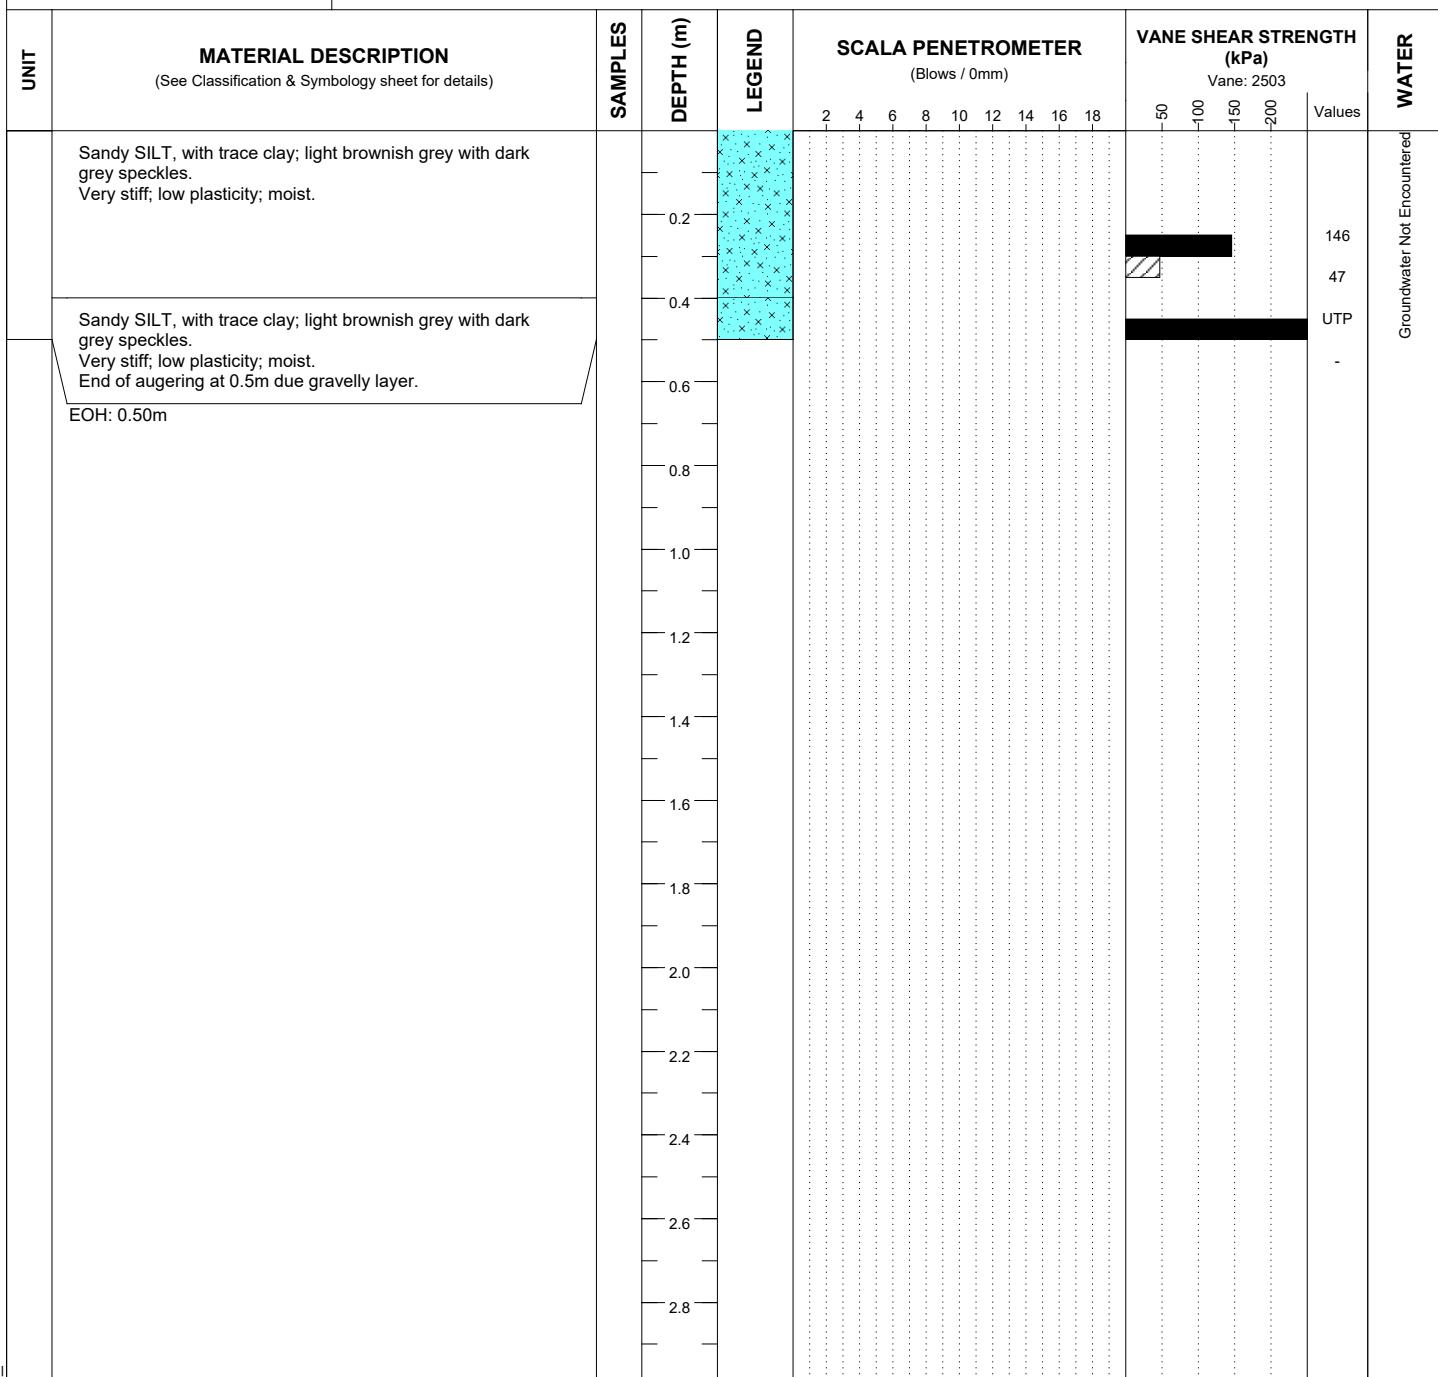
1. Test undertaken in Lot 130;
2. Coordinates taken using a hand held GPS. Estimate accuracy of +/- 4m.

We understand that the fill materials placed in Stage 12 were dominantly SILT from the Te Aute Road Havelock North Rymans development site. The hand auger boreholes at these lots generally encountered stiff to very stiff SILT or sandy SILT beneath a thin layer of topsoil. The maximum depth of these hand auger boreholes was 1.3 m below ground level.

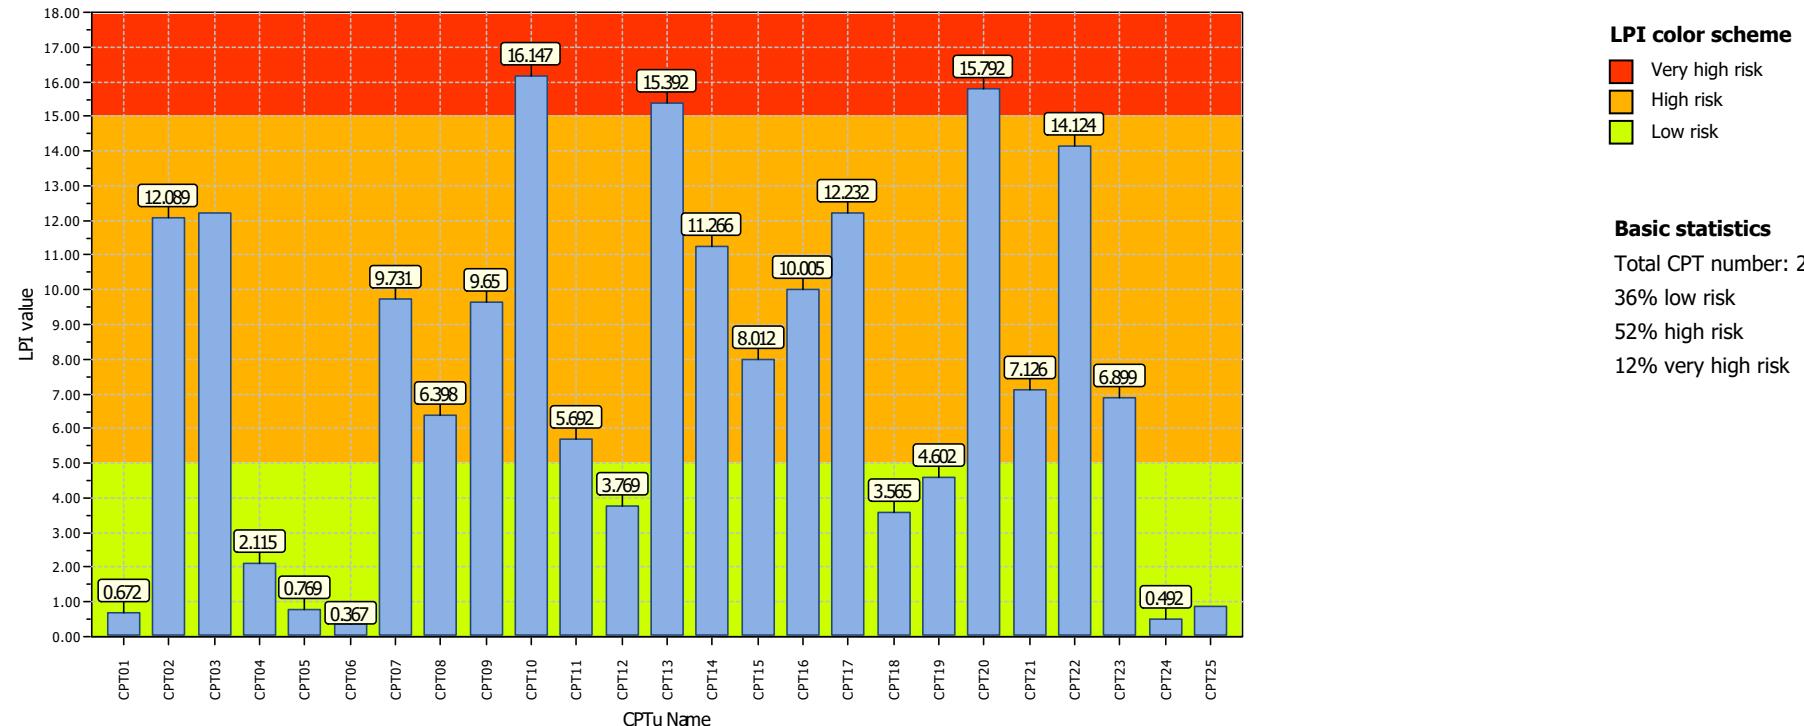
Overall Liquefaction Potential Index report

A CPT-based liquefaction analysis has been carried out using the computer programme CLiq v.2.3⁷ on the recent Initia CPTs. The adopted analysis method is based on the study by Boulanger and Idriss (2014).

The analysis indicates that the liquefaction susceptibility during the SLS design event is low across the site. For the ULS design event, the liquefaction susceptibility is estimated to be moderate to high across the site. When the liquefaction does occur in a ULS design earthquake event, the analysis indicates that the liquefaction induced settlement may be up to 160 mm. However, the 2.5 m crust of material above the groundwater level will likely form a 'cap' to reduce the effects of liquefaction observed at the surface.

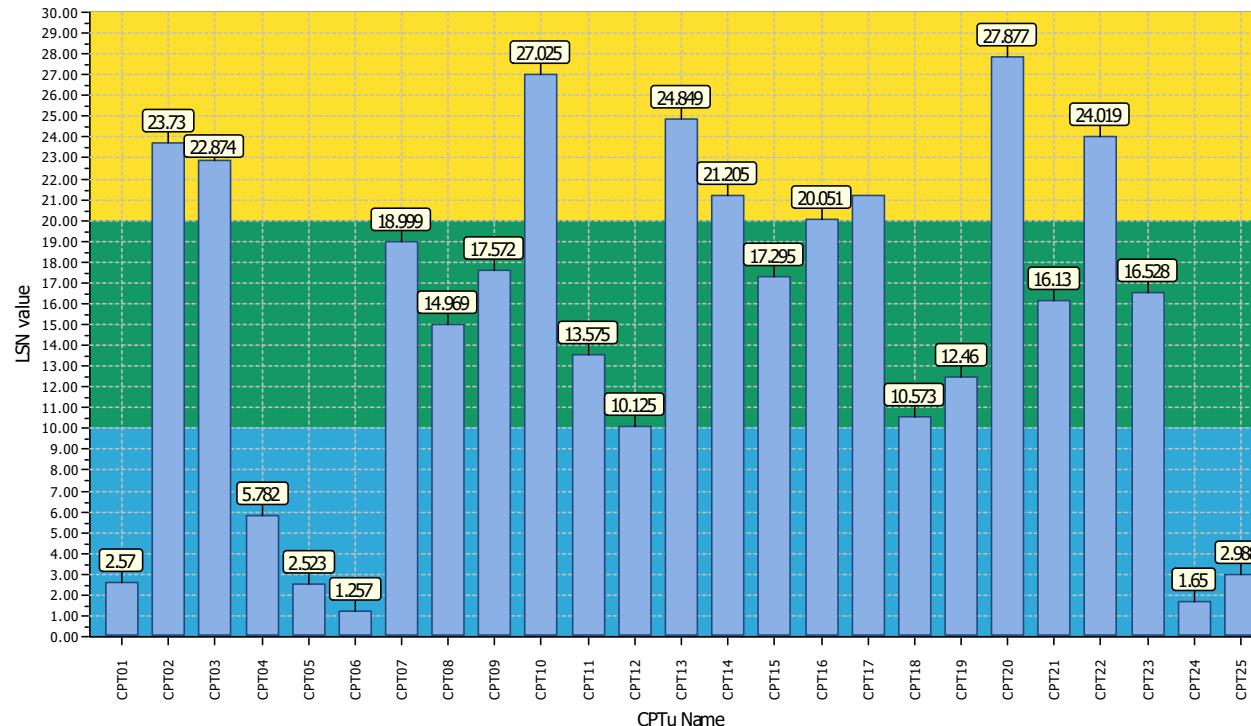
Overall Liquefaction Severity Number report

- Severe damage
- Major expression of liquefaction
- Moderate to severe exp. of liquefaction
- Moderate expression of liquefaction
- Minor expression of liquefaction
- Little to no expression of liquefaction
