**REPORT ON:
STAGE 10, LYNDHURST ROAD SUBDIVISION
FRIMLEY, HASTINGS**

LOTS 163 TO 178 (EXCLUDING LOT 171)

**PROJECT:
GEOTECHNICAL ASSESSMENT**

CLIENT: GREENSTONE LAND DEVELOPMENTS LTD.

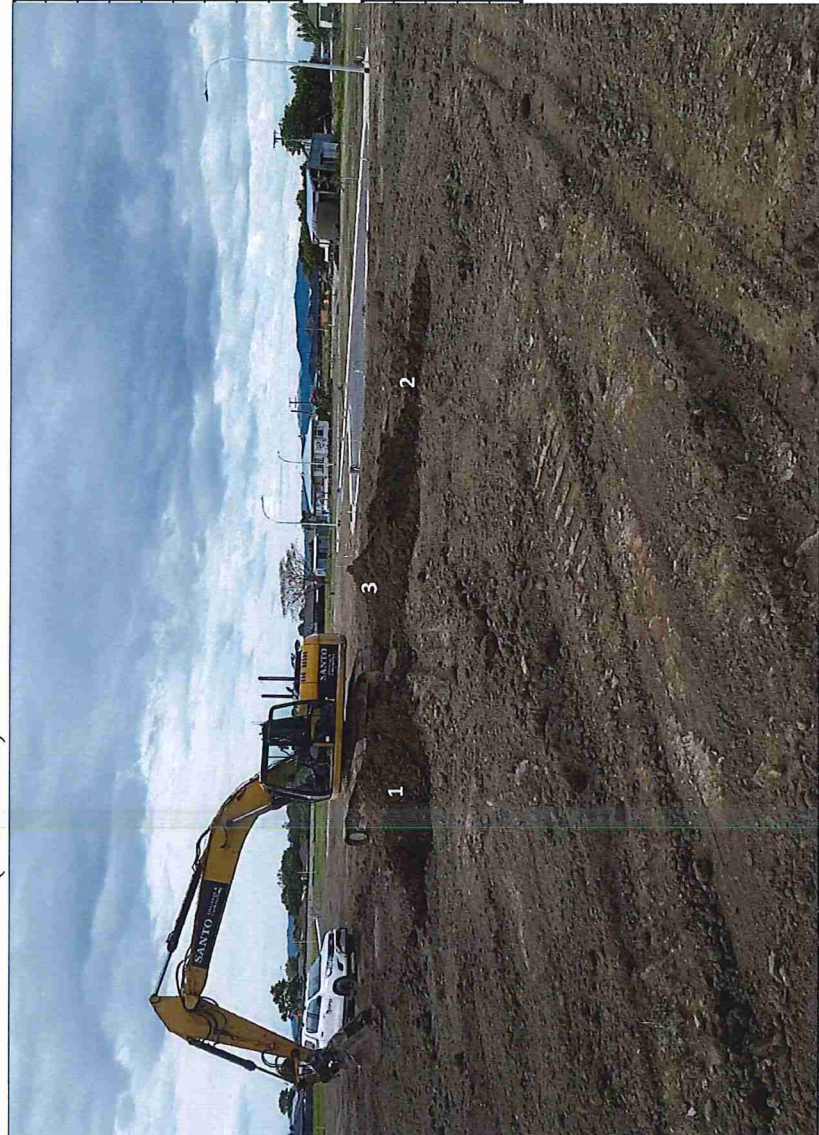
EARTHWORKS COMPACTION CONTROL TEST RESULTS

Nuclear Densometer Test Results			
Test Number	1	2	3
lot 172	lot 172	lot 172	lot 172
Probe Depth (mm)	300	300	300
Wet Density (t/m ³)	1.69	1.71	1.78
Dry Density (t/m ³)	1.28	1.37	1.36
Water Content (%)	32.0	25.1	31.0
Air Voids (%)	9.8	13.1	5.6
% of DD	96	102	101

Test Methods	Notes
In situ Density : NZS 4407 : 2015, Test 4.2 for Direct Transmission Mode
